# Migration of Kirschner Wire into the Spinal Canal as Complication of Inveterate Shoulder Luxation Treatment. Case Study.

<sup>1</sup> Division of Trauma and Orthopedic Surgery, Torrevieja Hospital, Alicante, Spain

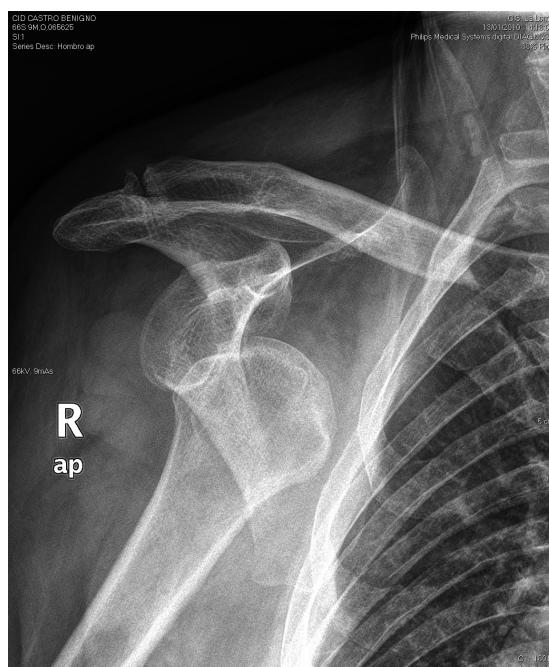
Fig. 1. X-ray of inveterate right shoulder luxation

A 66-year-old man was admitted to the emergency department of our hospital for inveterate anterior right shoulder luxation with a history of 22 days (Fig. 1). The dislocation was treated by close reduction and percutaneous fixation with a Kirschner wire

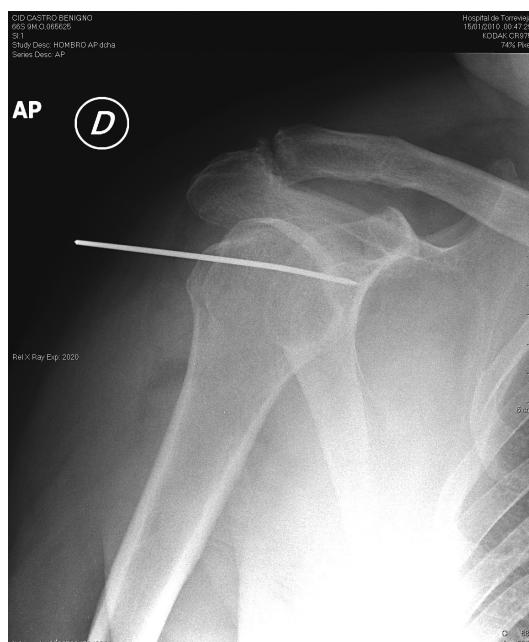
Fig. 2. X-ray – post-operative follow-up

to prevent secondary luxation. The smooth pin was introduced through the humeral head into the scapular glenoid fossa. The K-wire was cut, not bent and covered with the skin and soft tissues. Postoperative radiographs showed that the positions of the K-wire and the shoulder were appropriate (Fig. 2). A sling was used to immobilize the shoulder in the post-operative period. The patient was discharged on the first postoperative day. On day 26 after the operation he was admitted to the outpatient clinic for a routine follow-up examination. A follow-up x-ray showed

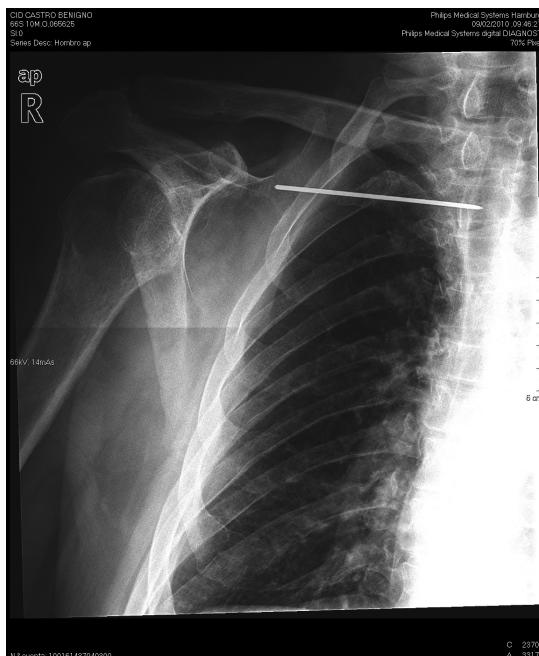
Fig. 3. X-ray – follow-up at 26 days after the surgery

intrathoracic migration of the K-wire without secondary luxation of the right shoulder (Fig. 3). He was symptom-free (no spinal cord symptomatology on neurological examination) but chest x-rays and CT scans indicated that the K-wire had migrated to the right thoracic cavity (Fig. 4). A thoracic computed tomography scan showed that the wire was in the right upper lobe and its tip was seen in the spinal canal entering through the right Th8 nerve root foramen (Fig. 5, Fig. 6). There was no evidence of a pneumothorax or hemothorax.

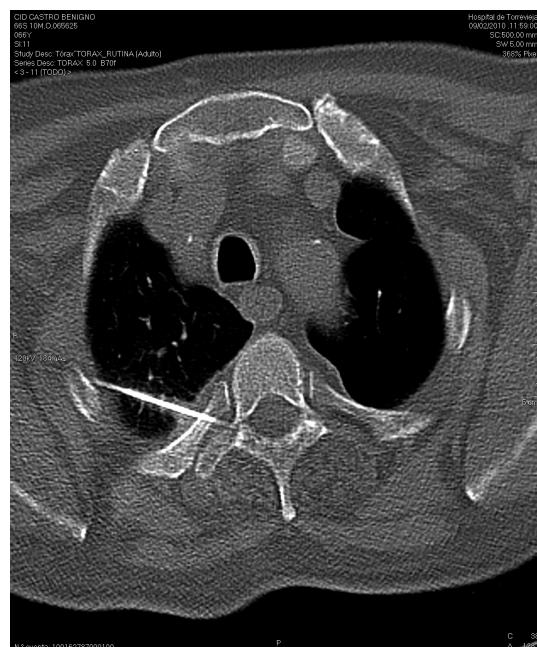
Fig. 4. CT scan – migration to the right thoracic cavity

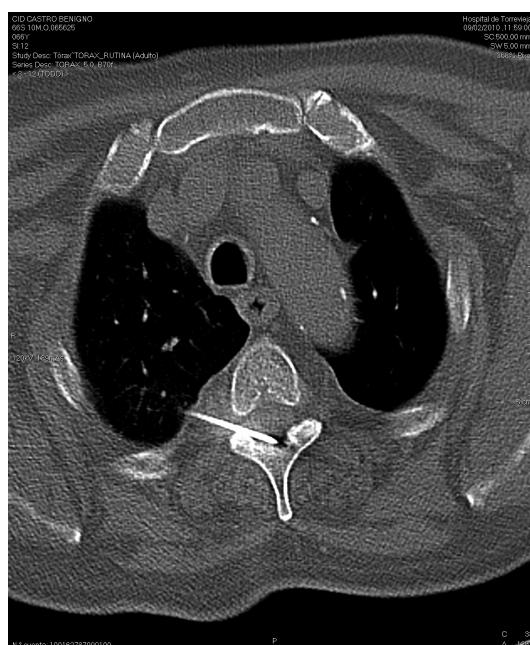
Fig. 5. CT scan – spinal canal entering through the right Th8 nerve root foramen

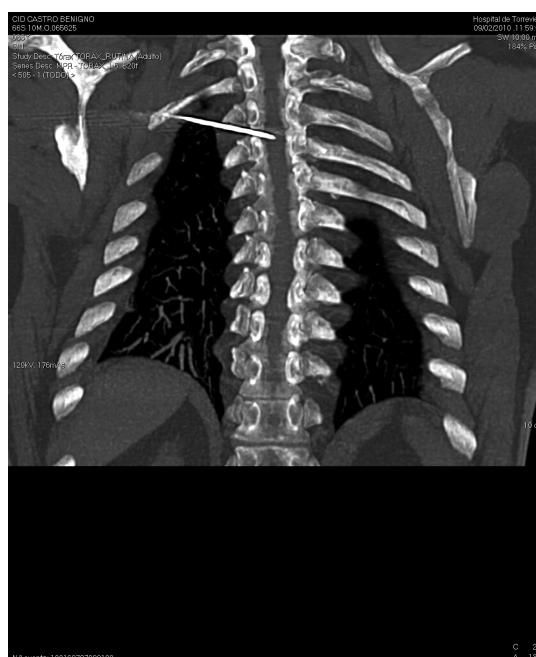
Fig. 6. CT scan – spinal canal entering through the right Th8 nerve root foramen

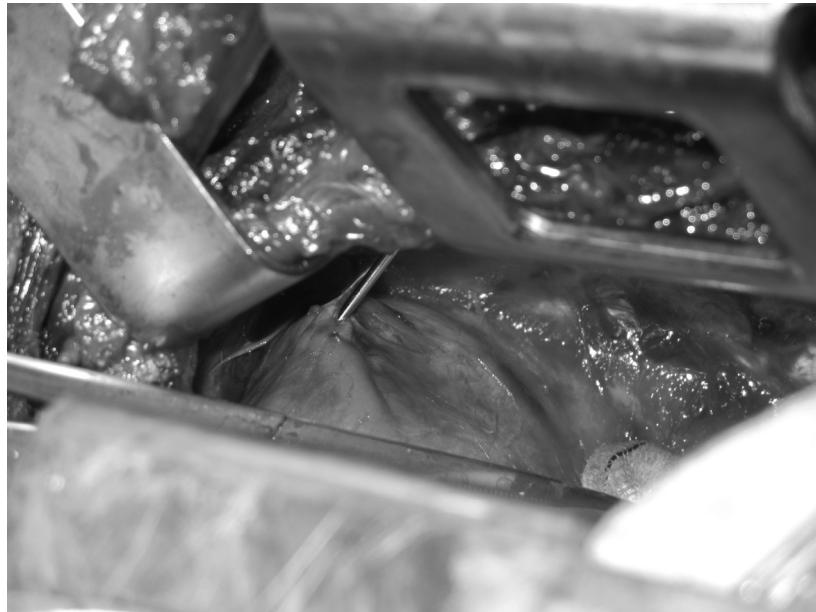
Fig. 7. Intraoperative photograph

The patient was taken to the operating room and a right posterolateral exploratory thoracotomy was performed. There was no active bleeding and no air leakage. The wire was found to be penetrating the right lung parenchyma and the pleura adjacent to the eighth costovertebral joint and entering the vertebral canal. The wire was carefully cut and removed in two pieces along its axis (Fig. 7, Fig. 8). The patient was discharged on the sixth postoperative day. The outcome was favourable.

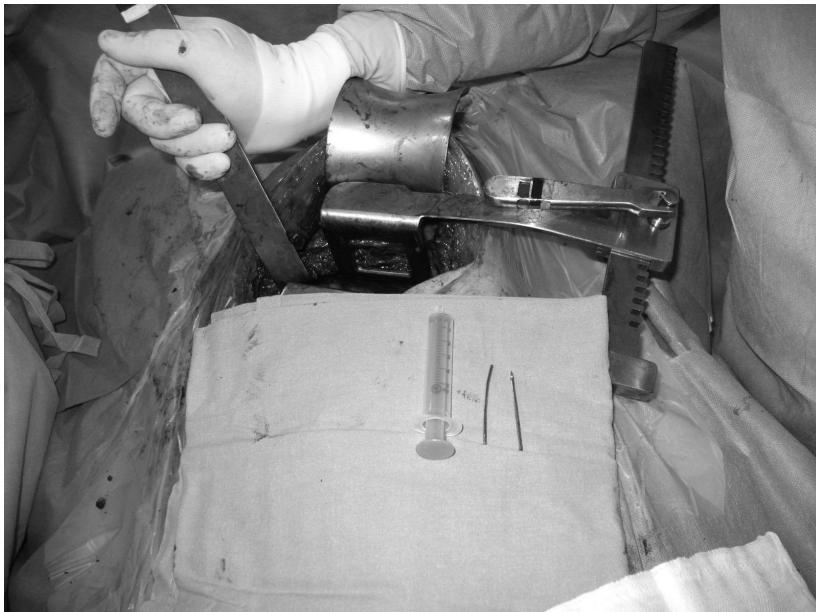
Fig. 8. Surgically removed K-wire
